100% MSBA Submission

Project Narrative

January 16, 2018
Window and Door Replacement Project Narrative

Halifax Elementary School
464 Plymouth Street, Halifax, MA 023398

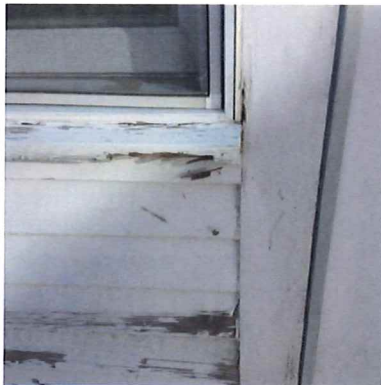
Photo W11: Rotted Window Sill

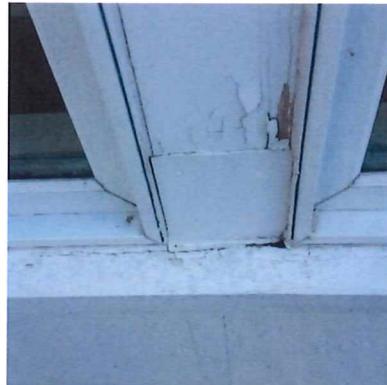
Photo W12: Damaged Center Trim

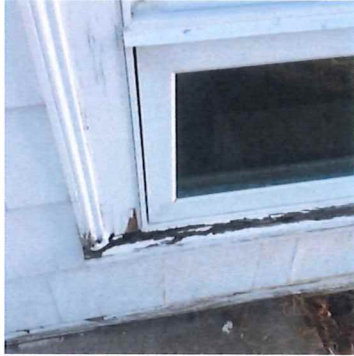
Photo W13: Rotted Window Sill

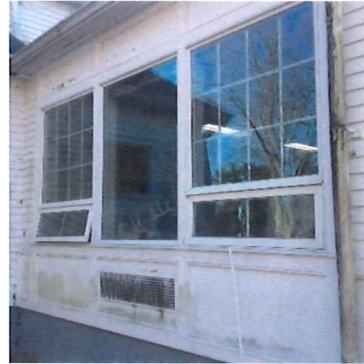
Photo W14: Broken Catch at Awning

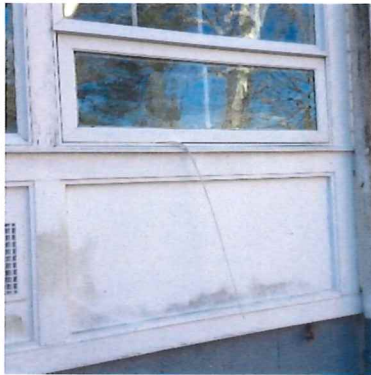
Photo W15: Broken Weatherstripping

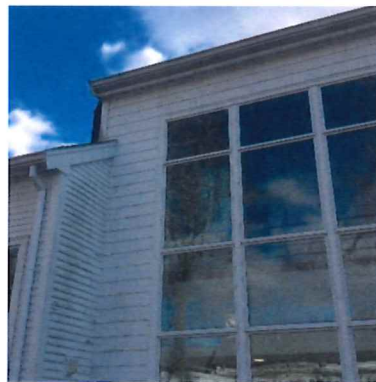
Photo W18: Fogged Window - Missing Gas in Glass

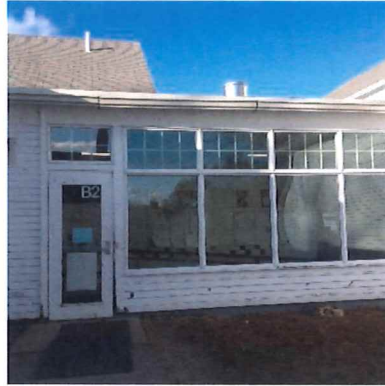
Photo D2: Rusted Door

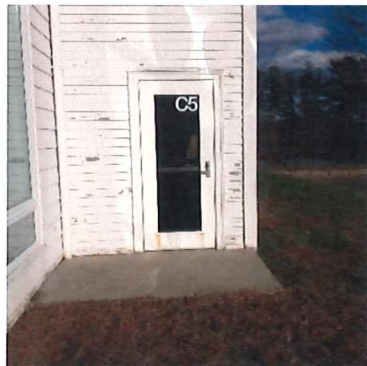
Photo D3: Rusted Door

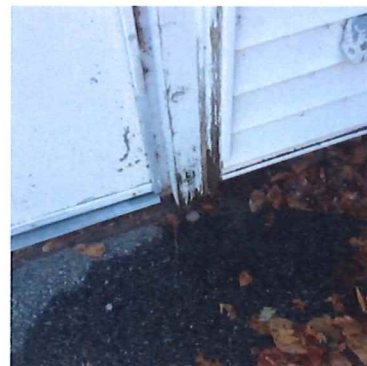
Photo D4: Rotted Door Trim

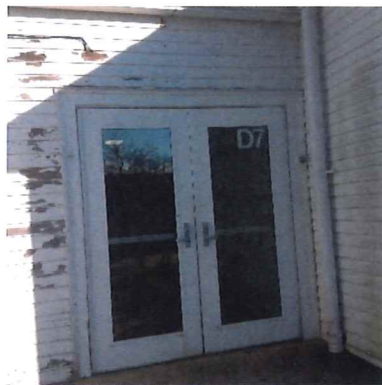
Photo D5: Rusted Double Door

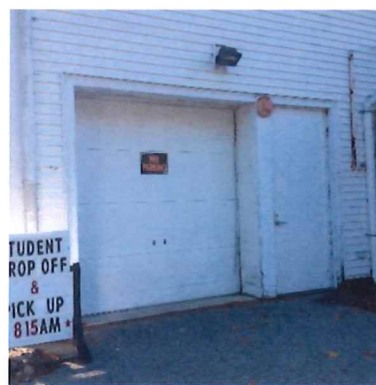
Photo D6: Overhead Door with Damaged Weatherstripping

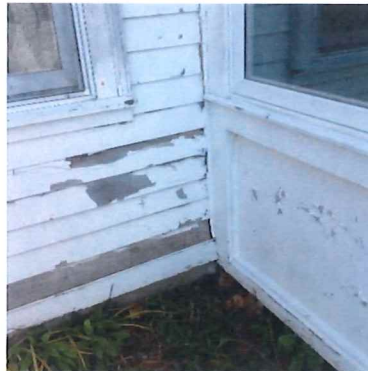
Photo S2: Rotted Siding

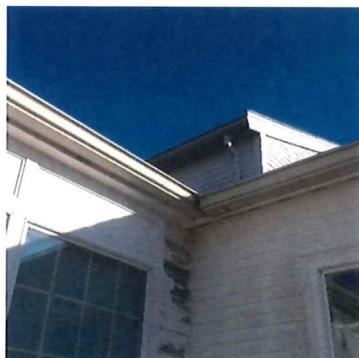
Photo S3: Rotted Siding

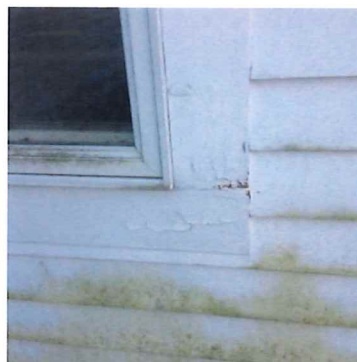
Photo S4: Damaged Paint

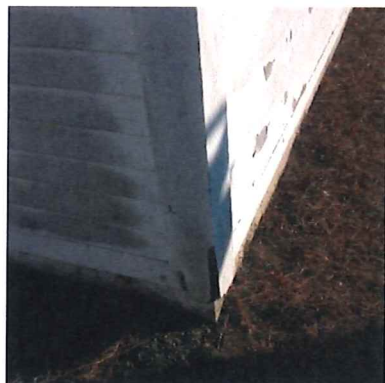
Photo S5: Rotted Corner Trim Boards

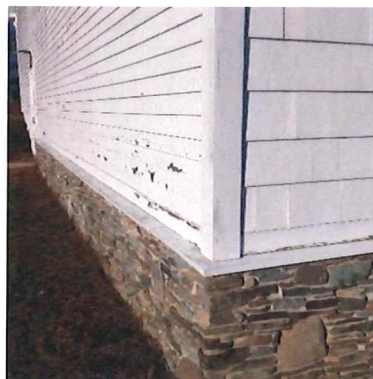
Photo S6: Peeling Paint

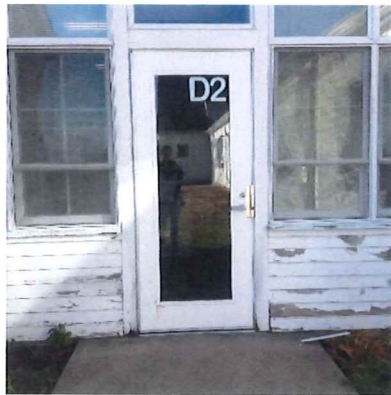
Photo S7: Peeling Paint

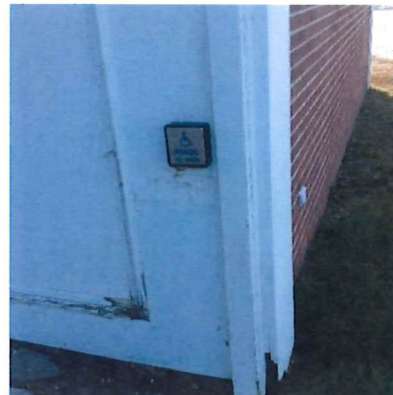
Photo S8: Rotted Trim Boards at Gym

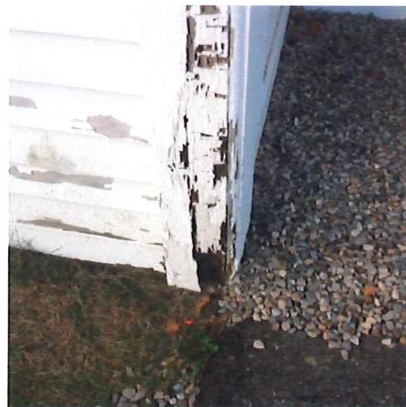
Photo S9: Rotted Corner Boards

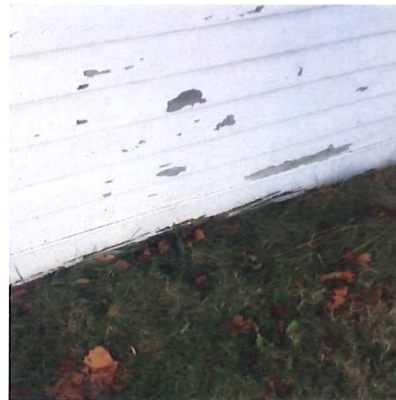
Photo S10: Rotted Wood Mudsill

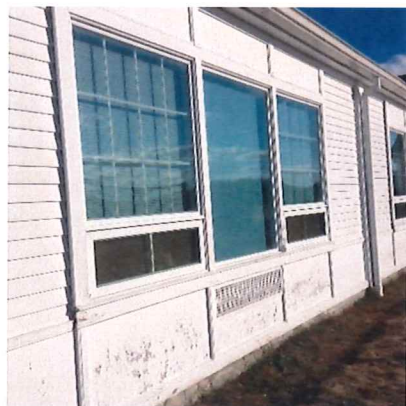
Photo S11: Peeling Paint at Paneling

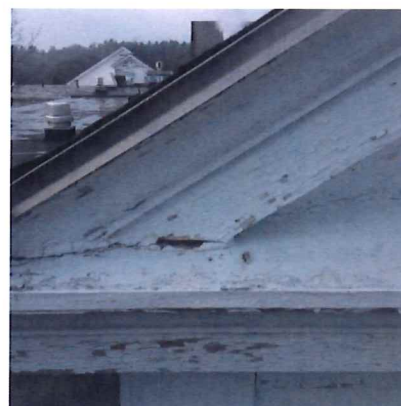
Photo S12: Peeling Paint at Original Cornice
