Halifax Elementary School

Fire Protection System Evaluation

Schematic Design Submission

March 3, 2017

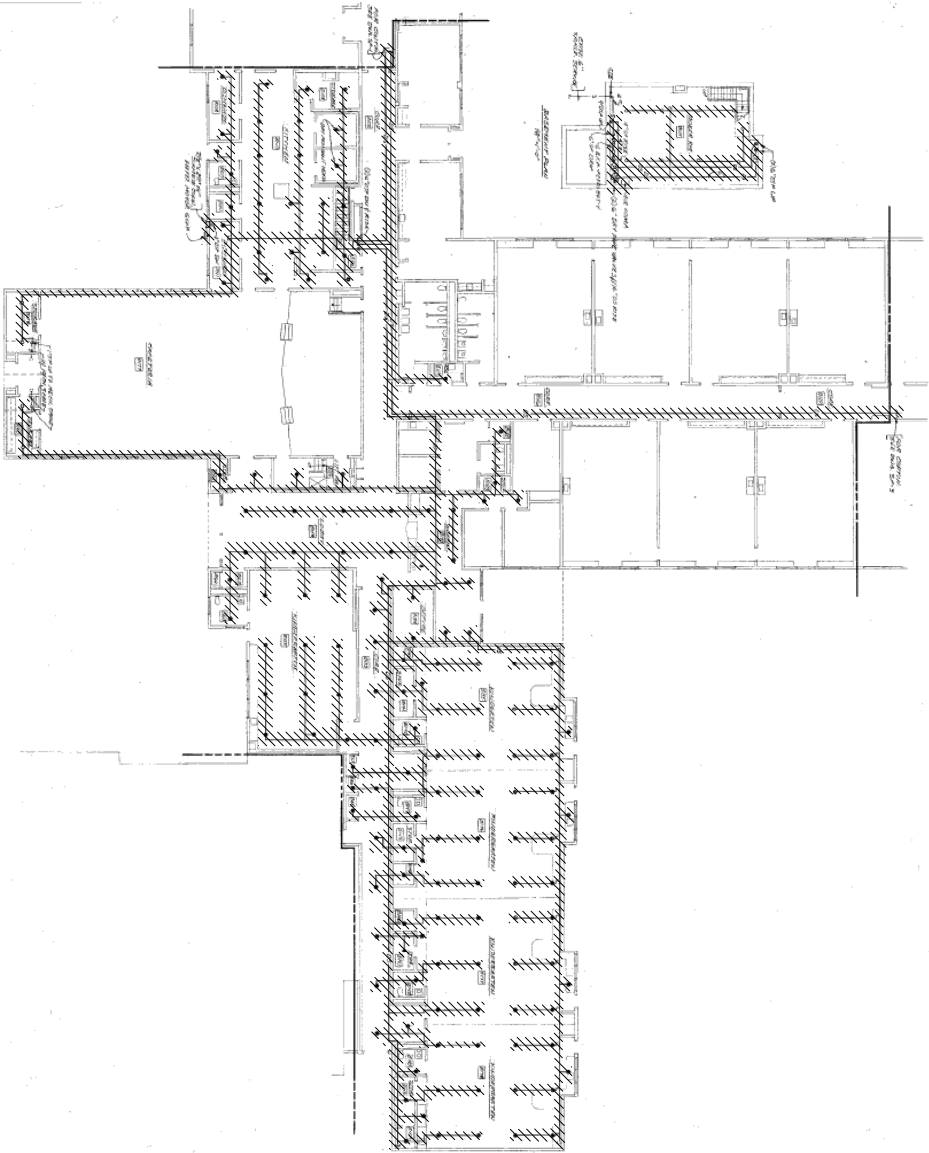
FP-101

- 2.1.1 6" water service enters the basement mechanical room. 6" supervisory gate valves, double check valve and 6" pipe header are located in the basement. 4" siamese connection and water motor gong are located outside. Two 4" dry pipe alarm check valves and supervisory gate valves are connected to a 6" header, (Refer to Photo 5.) Original air compressor is disconnected from the system. The size is too small. At present, an automatic control compressor is used to keep the air pressure in the system. (Refer to Photo 4.)
- 2.1.2 Schedule 40 steel pipes are used throughout the dry pipe system. Pipes are corroded and there are leaks at many places. Temporary pipe clamps are used to stop leaks.
- 2.1.3 Upright and pendant sprinkler heads are used in spaces.
- 2.1.4 Refer to drawings FP-100, FP-101, FP-102 & FP-103 for details.

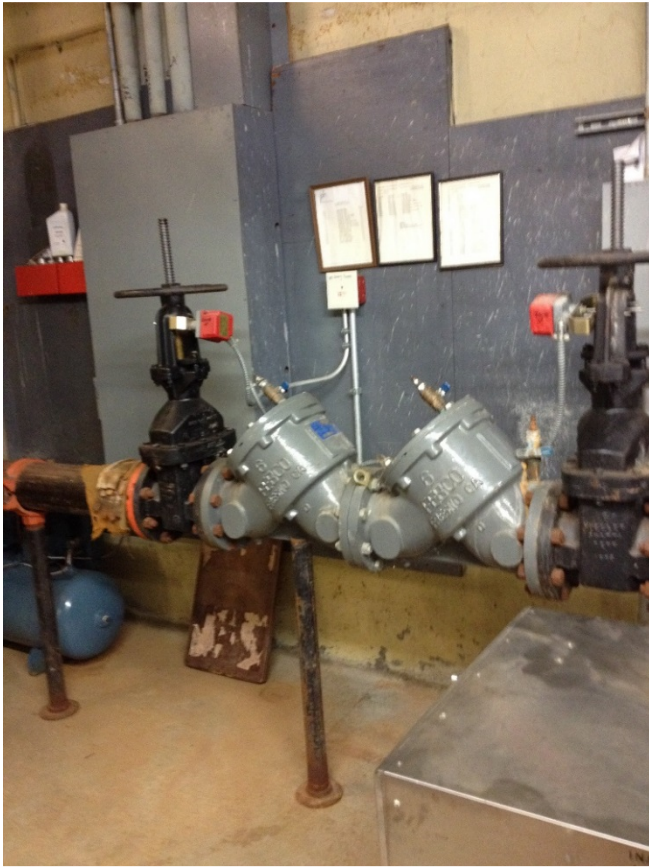
Photo 1: Backflow preventer

The existing 6" incoming service, double check valve, fire department connection & related items may be retained.

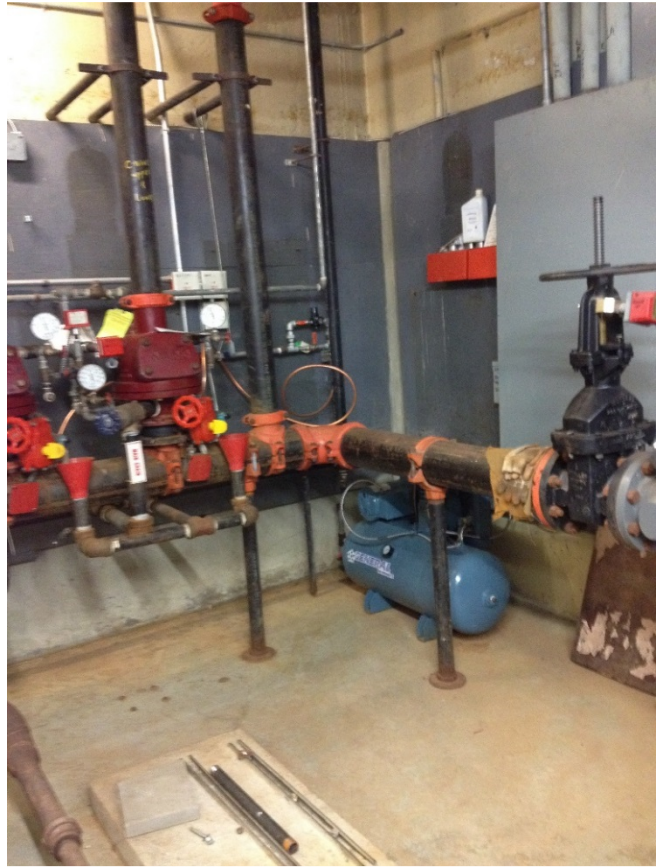
The existing sprinkler system is a dry system with two dry pipe main alarm check valves. (Refer to photos 2-5.) Compressed air is introduced into the system after the dry pipe alarm check valves. Schedule 40 steel pipes are installed throughout the system.

Photo 2: Dry Pipe Risers

Our recommendation is to replace the dry pipe alarm check valves, air compressor and steel pipes throughout the building.

Replace the dry pipe sprinkler system with a wet pipe sprinkler system with two wet pipe alarm check valves, Schedule 40 steel pipes throughout the building, quick response upright and pendant sprinkler heads for the entire school.

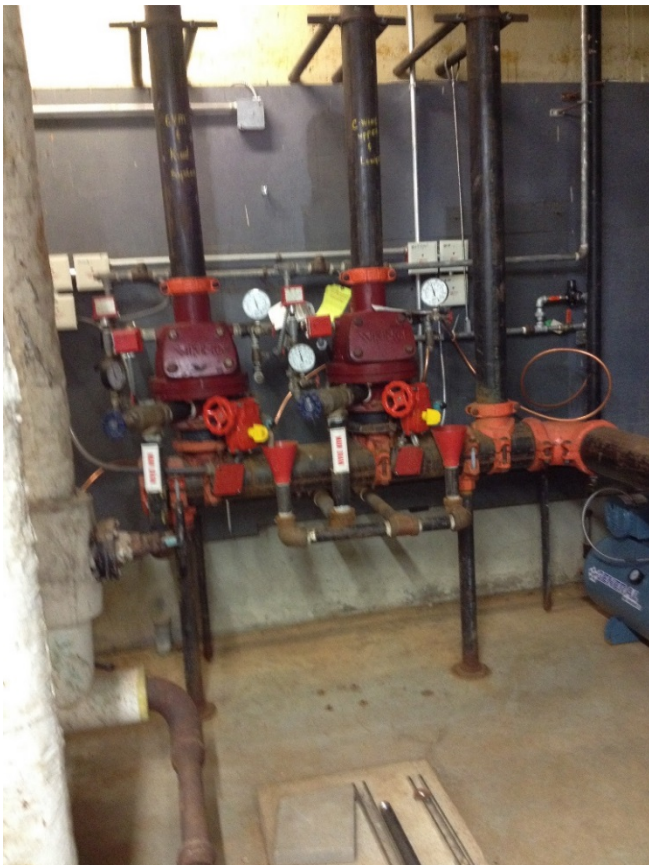
Photo 3: Dry Pipe Risers

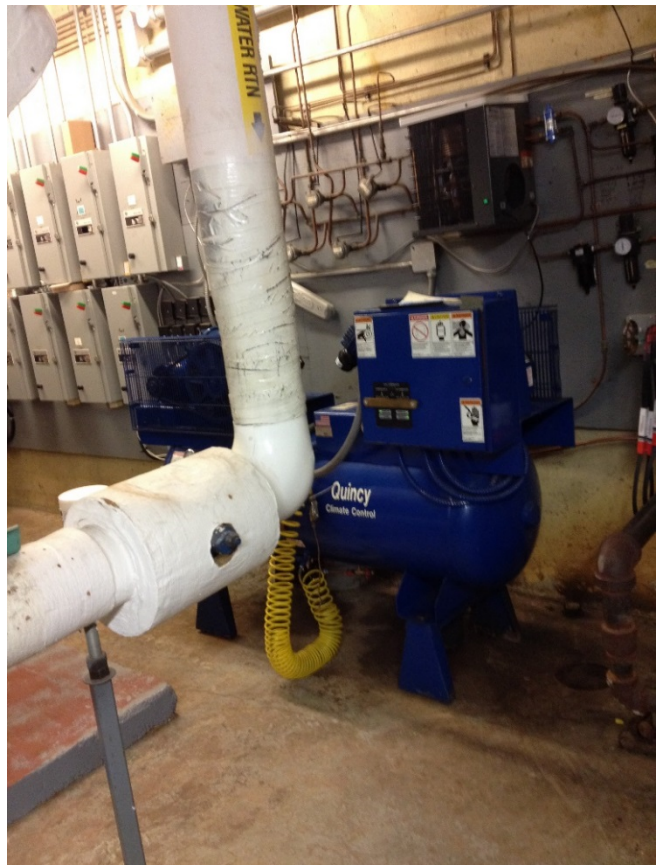
Photo 4: Temporary Air Compressor for Dry Pipe System

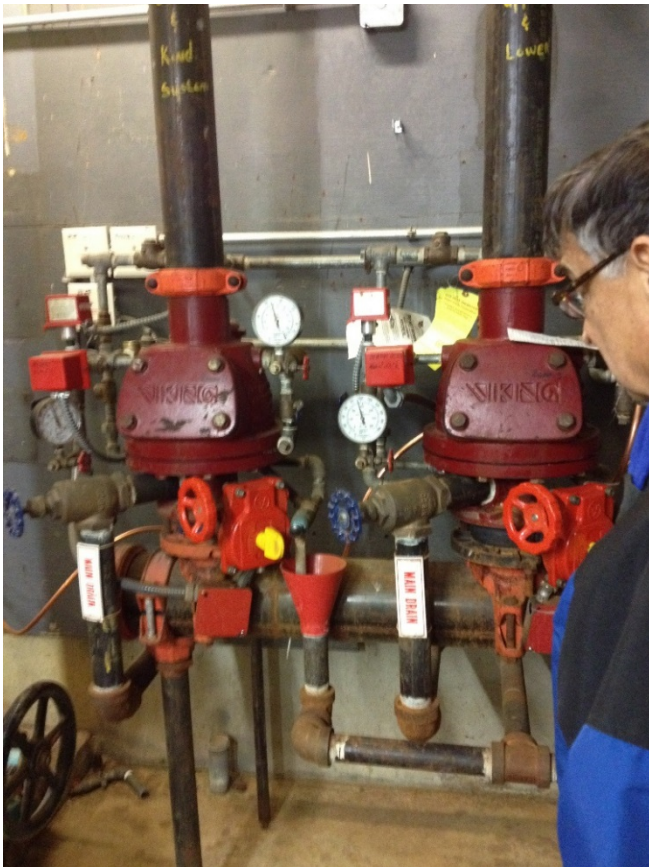
Photo 5: Dry pipe valves and accessories

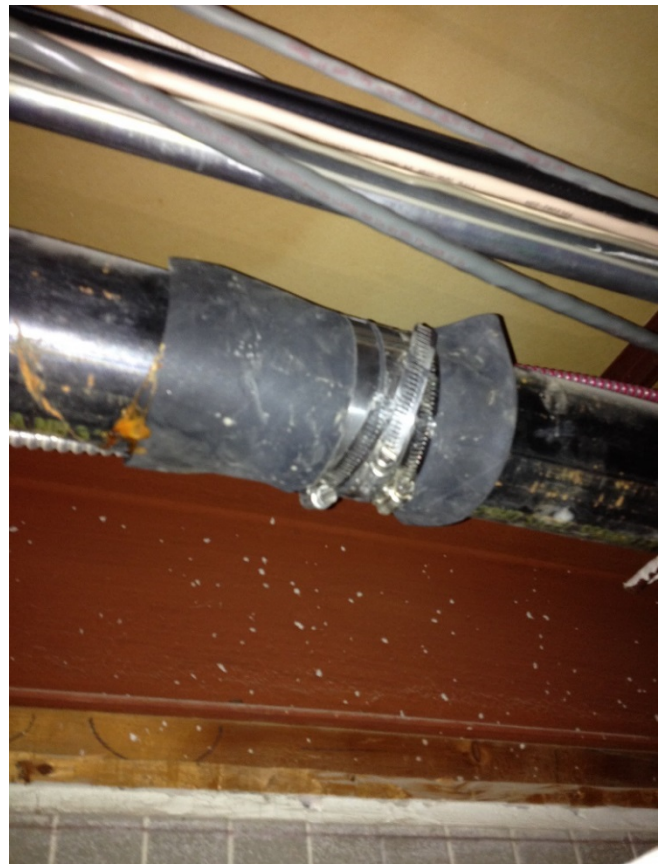
Since non-galvanized steel pipes are used, these pipes have corroded from the inside. Temporary patchwork is provided at many locations to stop the leaks. (Refer to Photo 8.) Leaky steel pipes are a major problem in the building.

Photo 8: Temporary patch for leaky pipe
